NATIONAL PROGRAM FOR INSPECTION OF NON-FEDERAL DAMS  
NOYES BROOK DAM (ME 0..10) CORPS OF ENGINEERS WALTHAM  
MA NEW ENGLAND DIV SEP 81

REPORT DOCUMENTATION PAGE		READ INSTRUCTIONS BEFORE COMPLETING FORM
1. REPORT NUMBER  ME 00347	2. GOVT ACCESSION NO.	3. RECIPIENT'S CATALOG NUMBER
4. TITLE (and Subtitle)  Noyes Brook Dam  NATIONAL PROGRAM FOR INSPECTION OF NON-FEDERAL DAMS		5. TYPE OF REPORT & PERIOD COVERED  INSPECTION REPORT

20. ABSTRACT (Continue on reverse side if necessary and identify by block number)  >The earthfill embankment is 1000 ft. long and 31 ft. high. The facility was found in good condition. It is small in size with a high hazard classification. No urgent or emergency actions are required for the dam based on this inspection.

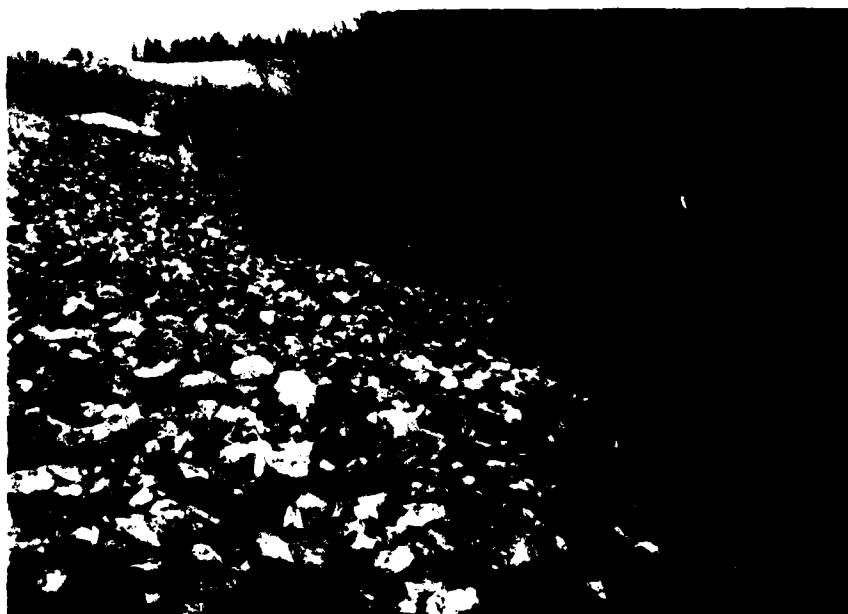
Photo 3  
Downstream Toe  
Seepage Area  
& Toe Drain Detail

(4) Downstream toe - The downstream toe is generally dry with no boils or seeps observed except at the toe drain (Photo 3). On the right side of the riprapped toe drain near sta. 25+00, a 1 1/2 gal/sec seep was issuing from the riprap. The flow carried no sediment or suspended fines (Photo 6).

- a. Monitor the seepage at the toe of the dam on at least a monthly basis. If any significant change in the flow volume or coloration is observed, engage a qualified registered professional engineer to determine its significance.
- b. Implement a monthly visual inspection program of the dam and appurtenances. Observations should be recorded in a maintenance log.
- c. Establish a system to monitor the project during periods of intense rainfall.
- d. Develop a downstream warning plan in the event of an emergency at the dam.
- e. Conduct bi-annual technical inspections of the project.
- f. Establish regular maintenance procedures at the project and continue to keep the embankments free of brush and trees.
- g. Remove the brush and trees from the downstream toe to a distance approximately 25' downstream.

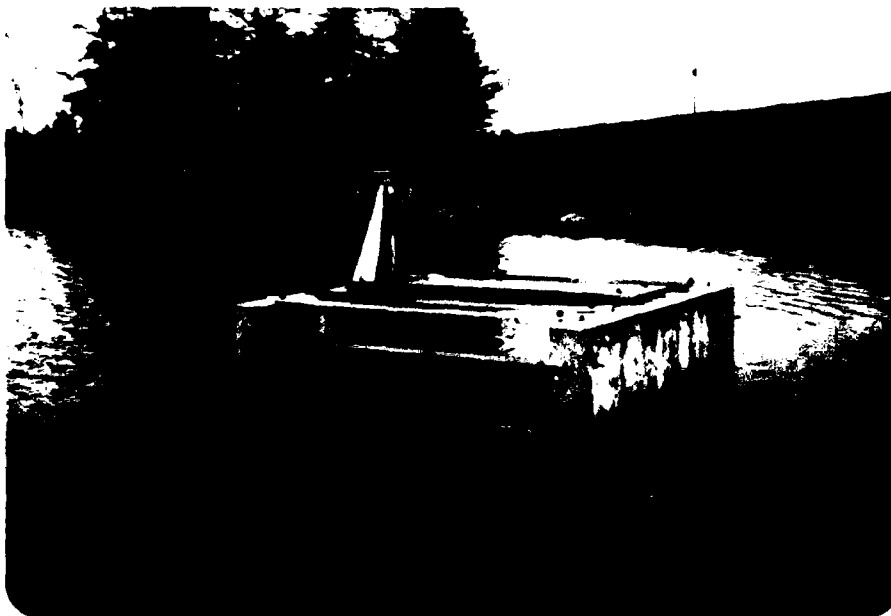
Photo 4  
Principal Spillway

(1) Principal Spillway - The principal spillway intake (Photo 4) was observed from shore. The exposed concrete and trashrack steel appeared in good condition.

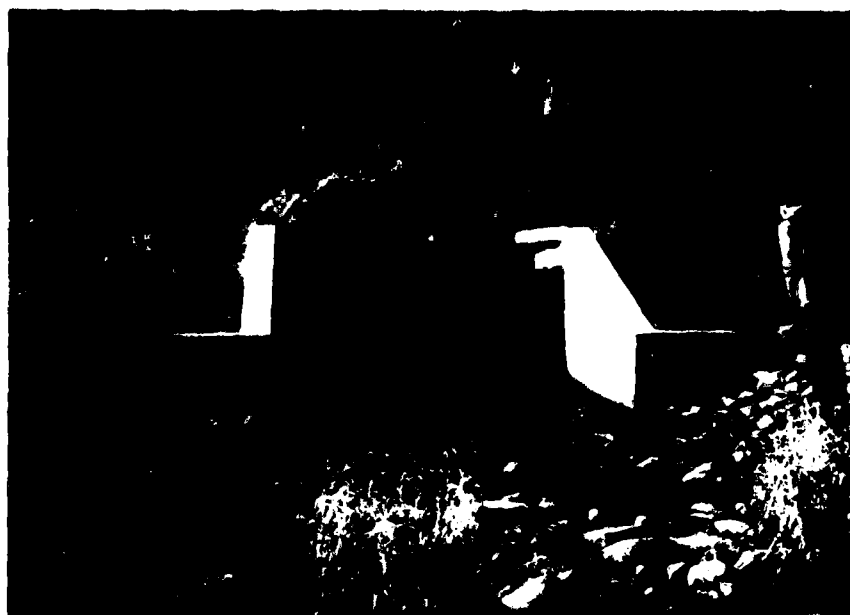
Photo 5  
Impact Basin &  
Underdrain Outfalls

(2) Outlet works - The outlet impact basin (Photo 5) was found in good condition. All construction joints were tight. No spalling was observed. The reservoir drain inlet was submerged and could not be inspected. The outlet conduit could not be inspected. It was reported by the Project Operator (Limestone Town Manager) that the drain had not been recently operated.

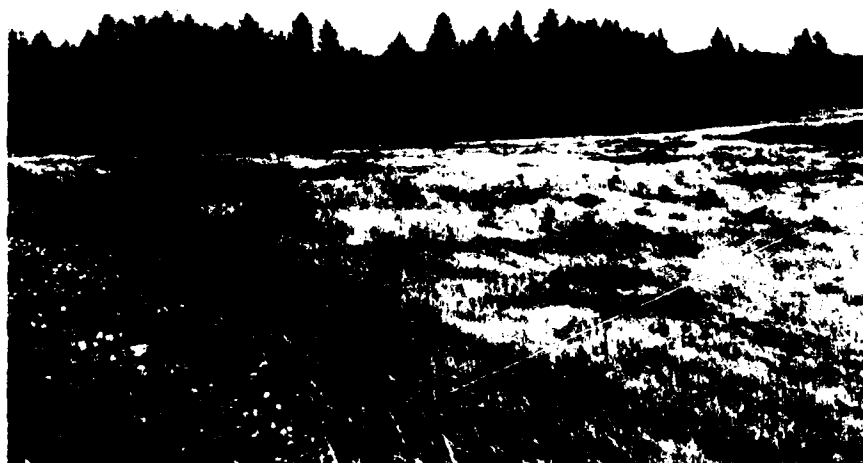
Photo 11

(3) Emergency spillway - The emergency spillway was clear of debris and in good condition with a well developed grass cover.

Emergency Spillway  
viewed from left  
embankment looking  
downstream.
